TEST REPORT

Report No. : 10-04-EAT-127-E06-A
Applicant : HY-LINE AG
Address : Gründenstrasse 82, 8247 Flurlingen Schweiz
Commodity : Li-ion Battery Pack
Model : H2B2722
Quantity : 24 pcs
Date of Receipt : Apr. 06, 2010
Date of Testing : May 26, 2010~ Jul. 17, 2010
Ambient Environment : Temp. 25~29°C , R.H. 56~71%
Testing Item : Refer to next page

1. Altitude simulation test
2. Thermal test
3. Vibration test
4. Shock test
5. External short circuit test
6. Overcharge test

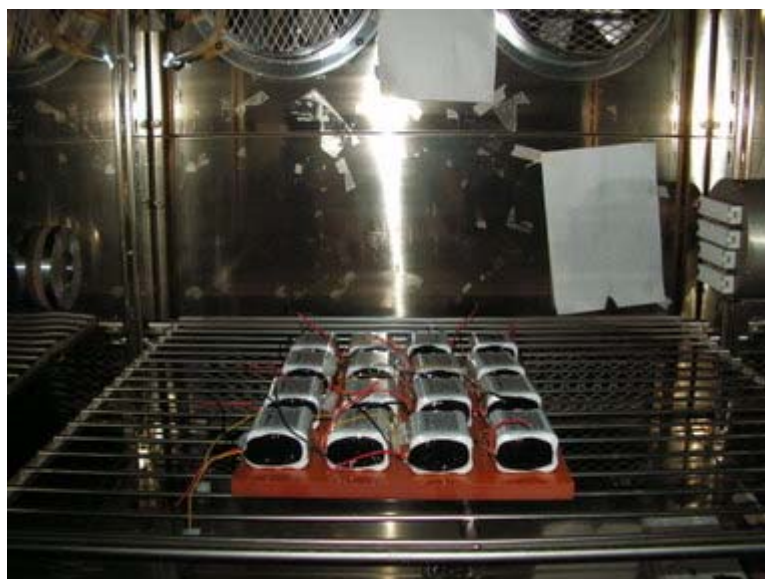
Fig.1 : Altitude simulation test

1. Altitude simulation test

Sample condition : As shown in Fig.1

Pressure : 11.6 kPa

Temperature : 20°C

Duration : 6 hrs.

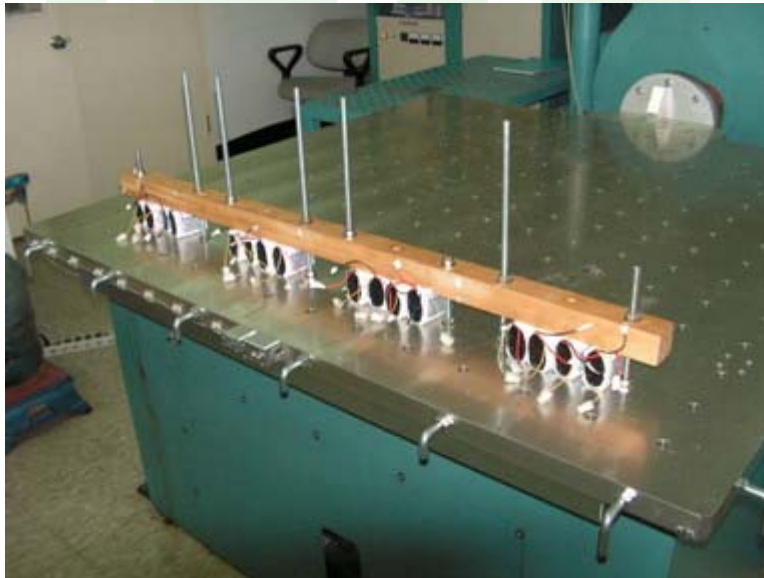
Fig.3 : Vibration test

3. Vibration test

Sample condition : As shown in Fig.3

Waveform : Sine wave

Frequency : (7 ~ 200 ~ 7) Hz

Amplitude : 1.6 mm (18~ 50) Hz

Acceleration : 1g (7~ 18) Hz / 8g (50~ 200) Hz

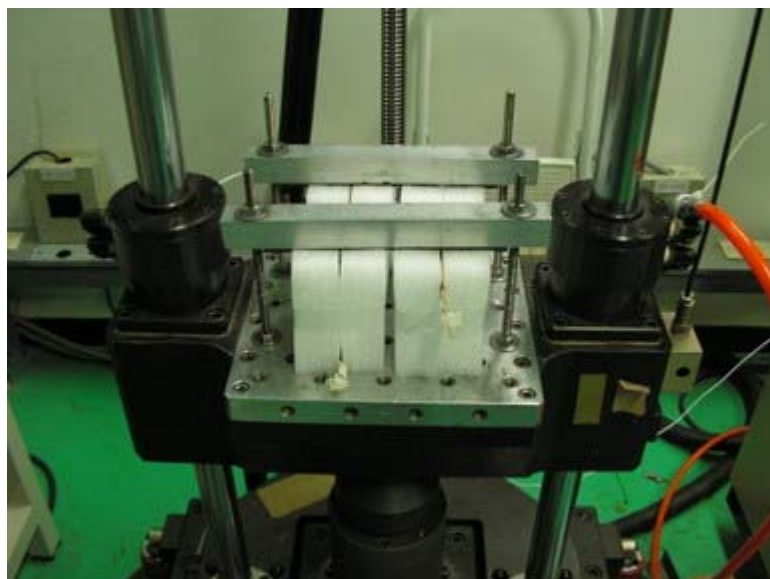
Fig.4 : Shock test

4. Shock test

Sample condition : With fixture (As shown in Fig.4)

Pulse shape : Half-sine pulse

Peak acceleration : 150 g

Duration of pulse : 6 ms

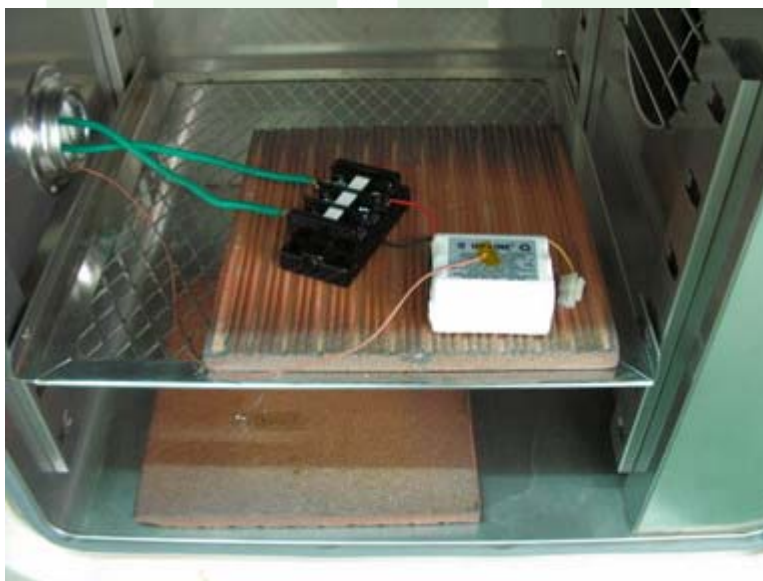
Fig.5 : External short circuit test

5. External short circuit test

Sample condition : As shown in Fig.5

Temperature : 55°C

External resistance : $< 0.1 \Omega$

Duration : 1 hr after the specimens temperature has returned to 55°C

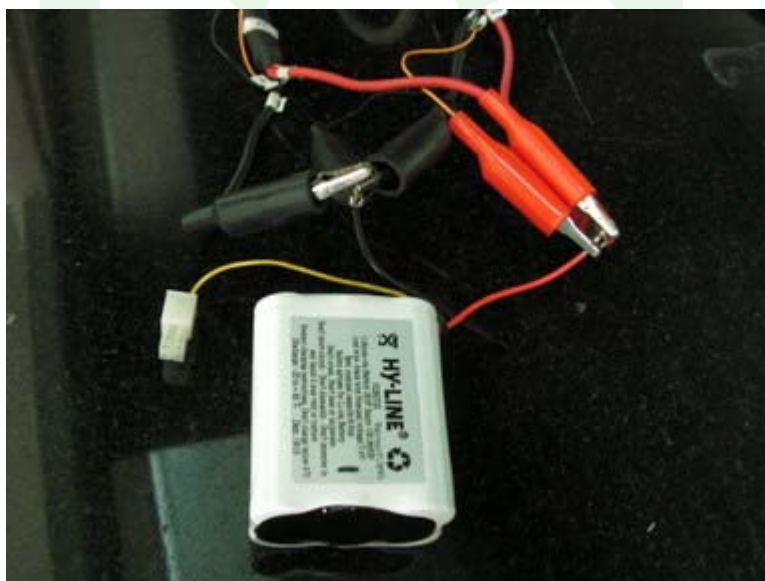
Fig.6 : Overcharge test

6. Overcharge test

Sample condition : As shown in Fig.6

Current : 9.66A

Voltage : 16.8V

Duration : 24 hrs.

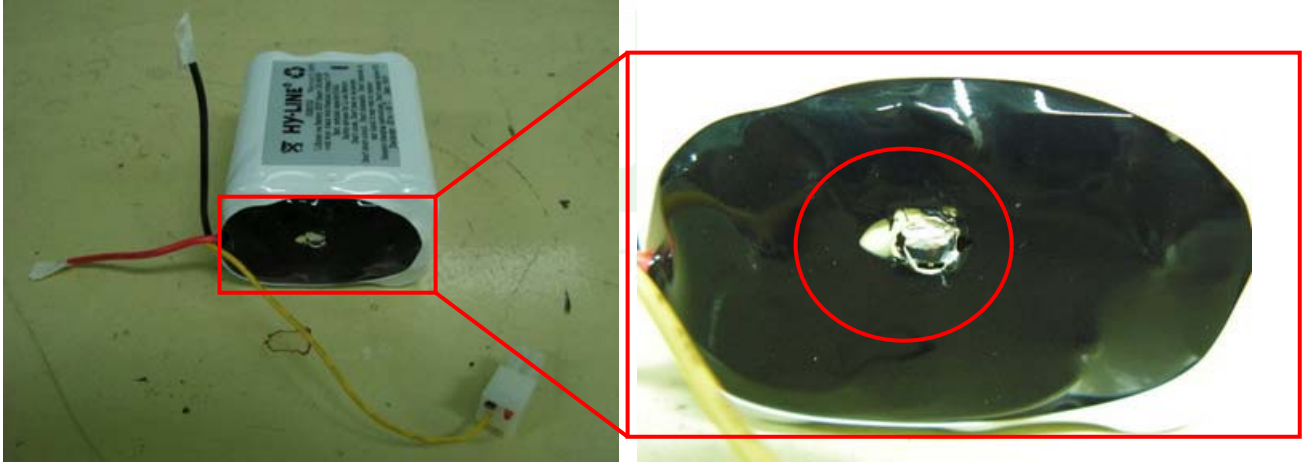
Fig.7 : The illustration of surface damage

Sample No.	Description	Remark
#1	1. No disassembly 2. No fire	The surface of all samples are damaged after test. (Refer to Fig. 7)
#2	1. No disassembly 2. No fire	
#19	1. No disassembly 2. No fire	
#20	1. No disassembly 2. No fire	
#21	1. No disassembly 2. No fire	
#22	1. No disassembly 2. No fire	
#23	1. No disassembly 2. No fire	
#24	1. No disassembly 2. No fire
