TEST REPORT

Report No. : 10-04-EAT-127-E05
Applicant : HY-LINE AG
Address : Gründenstrasse 82, 8247 Flurlingen Schweiz
Commodity : Li-ion Battery Pack
Model : H2B298
Quantity : 24 pcs
Date of Receipt : Apr. 06, 2010
Date of Testing : May 26, 2010~ Jul. 14, 2010
Ambient Environment : Temp. 25~29°C , R.H. 56~71%
Testing Item : Refer to next page

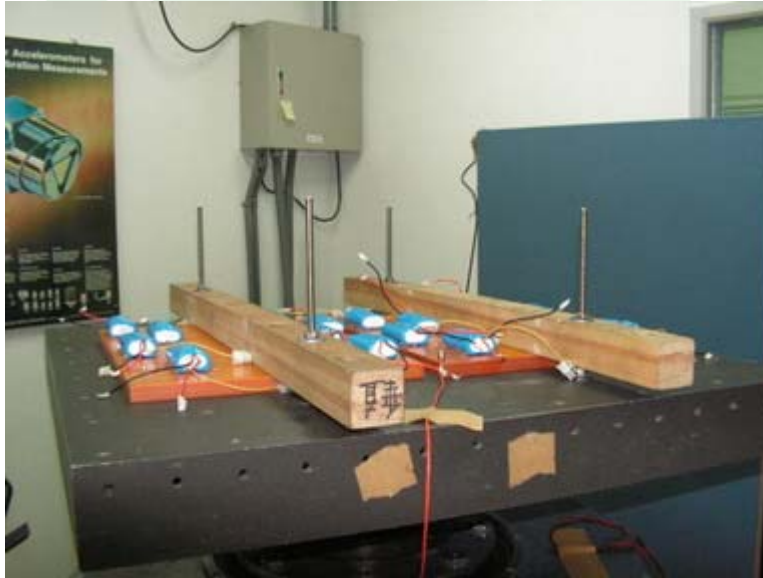
Fig.3 : Vibration test

3. Vibration test

Sample condition : As shown in Fig.3

Waveform : Sine wave

Frequency : (7 ~ 200 ~ 7) Hz

Amplitude : 1.6 mm (18~ 50) Hz

Acceleration : 1g (7~ 18) Hz / 8g (50~ 200) Hz

Direction : X, Y, Z (3 axes)

Duration : 3 hrs. / axis

3. Vibration test

Sample No.	Description
#1~#16	1. Mass loss did not exceed 0.1% 2. The voltage of #1~#4 and #9~#12 after test are not less than 90% of pre-test value 3. No leakage 4. No venting 5. No disassembly 6. No rupture 7. No fire

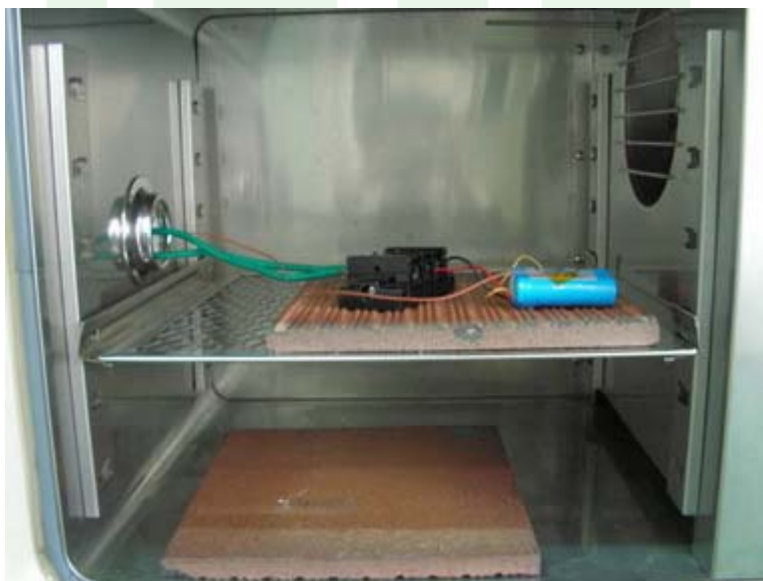
Fig.5 : External short circuit test

5. External short circuit test

Sample condition : As shown in Fig.5

Temperature : 55°C

External resistance : $< 0.1 \Omega$

Duration : 1 hr after the specimens temperature has returned to 55°C

5. External short circuit test

Sample No.	Description
#1~#16	1. External temperature didn't exceed 170°C 2. No disassembly 3. No rupture 4. No fire

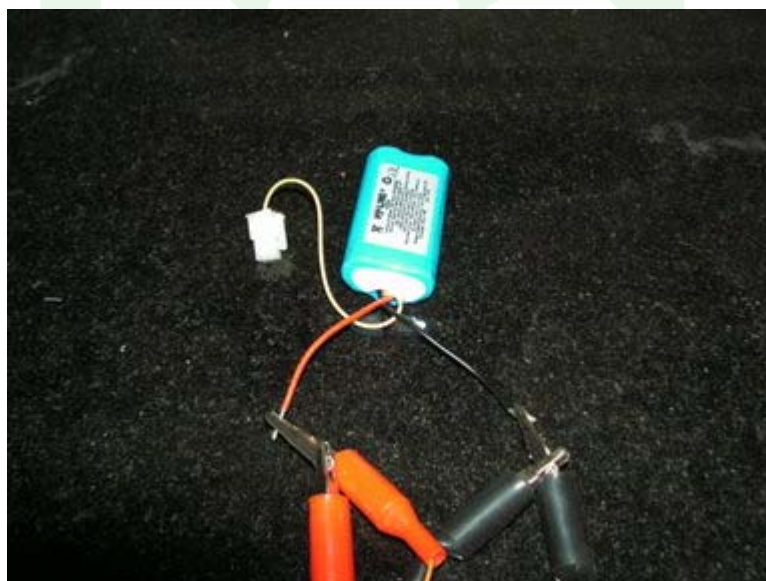
Fig.6 : Overcharge test

6. Overcharge test

Sample condition : As shown in Fig.6

Current : 2.5A

Voltage : 16.8V

Duration : 24 hrs.

6. Overcharge test

Sample No.	Description
#17~#24	1. No disassembly 2. No fire
